| | Management Process15S144 | | |
| + | Plant / Area: Milperra | Version: 5.0 | |

Milperra Pollution Incident Response Management Plan

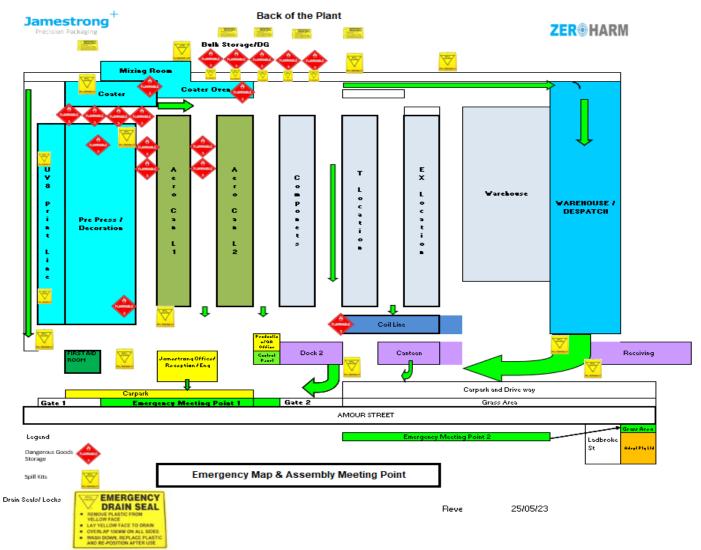
### MAP 1

Storm water locked drains, DG storage and Spill kit's locations shown in MAP 1

Refer to Work Cover Dangerous Goods manifest of onsite dangerous goods showed on Site Mud Map 1.

There are 19 spill kits placed near the identified spill danger areas. These spill kit locations are shown in the site map below.

There are 18 stormwater isolations exit but only 5 at the back yard and 2 in front yard have shut off valves that are detailed on the site mud map 1 below.
